# Manhole Inspection Summary

Manhole # S29EE1004MH

**Location** Address: **3891 BEACH AVE**

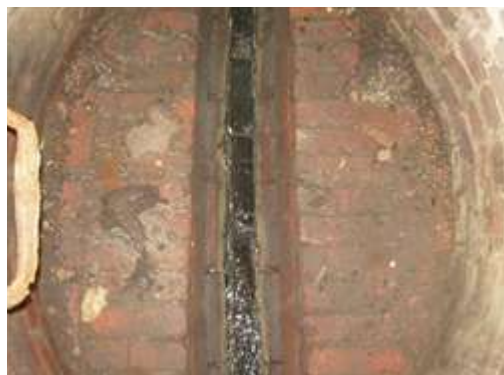
Top View

**Steps** Count: **1** Missing: **0** ☒ **Corroded**

Corroded step. Bench debris.

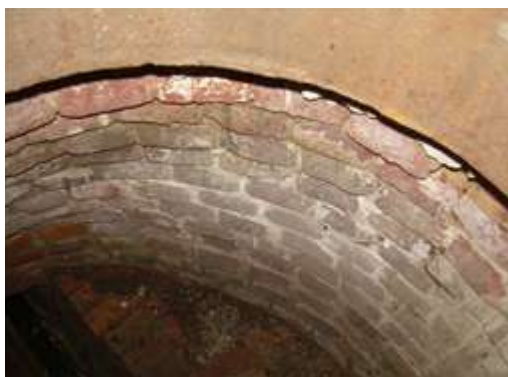
Defect

Infiltration: ☐ None ☒ **Joint** ☐ Cracks ☒ **Mortar** ☐ Roots ☐ Wall

Infiltration: ☐ None ☐ Joint ☐ Cracks ☒ **Mortar** ☐ Roots ☒ **Wall**

Corbel and Barrel infiltration.

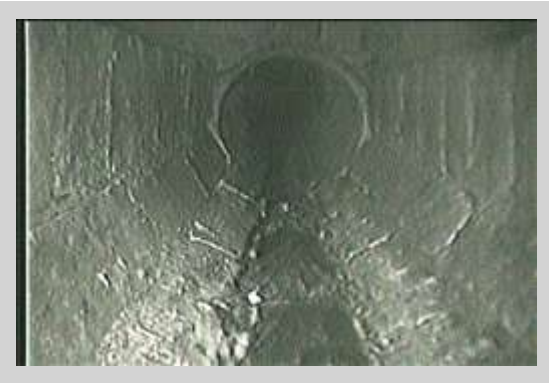
### 8 in. Circular Gravity Sewer Pipe Out @ 12 O'Clock

Infiltration: **Evidence** Pipe Seal Cond: **Cracked**
